RAHWAY RIVER BASIN
SOUTH BRANCH ROCKAWAY CREEK
HUNTERDON COUNTY
NEW JERSEY

LAKE CUSHETUNK DAM NJ 00347

PHASE 1 INSPECTION REPORT NATIONAL DAM SAFETY PROGRAM

August, 1979

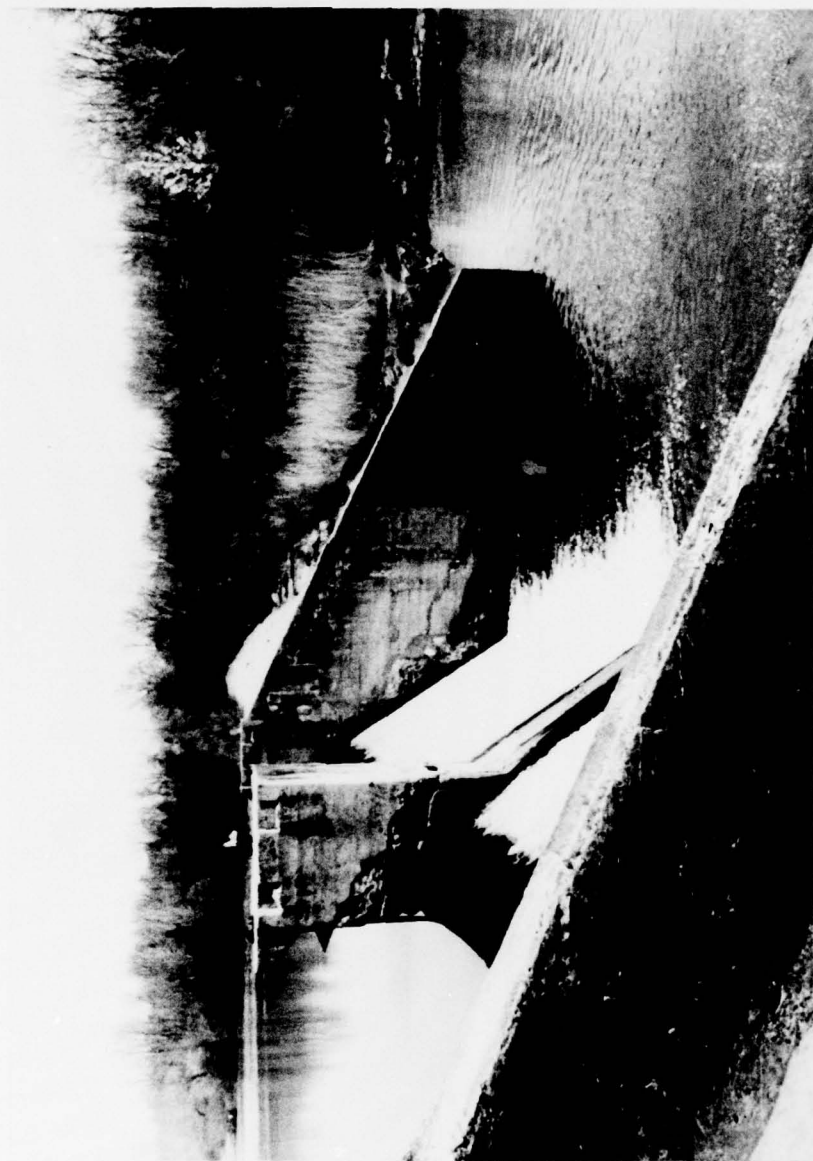
Lake Cusketunk Dam
Overall view of dam from the right.

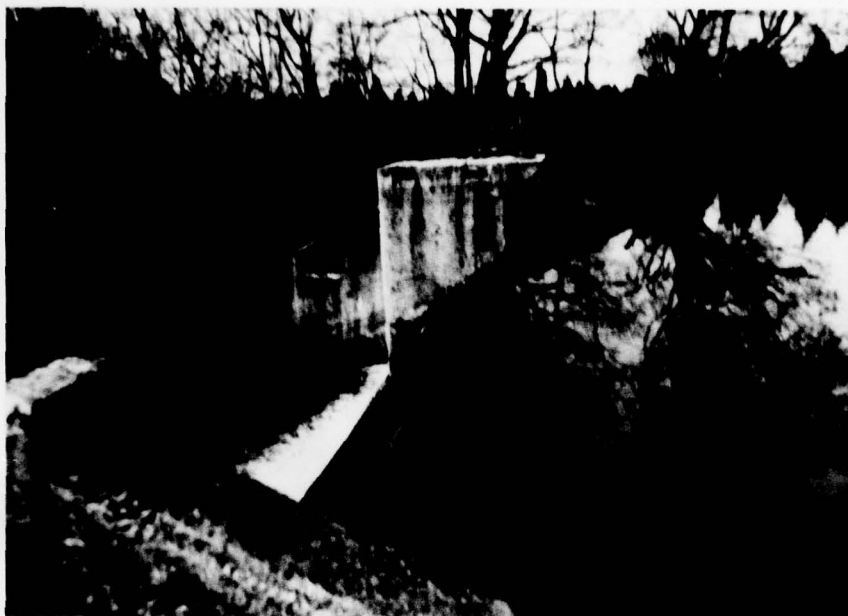
The original footbridge giving access across the spillway and to the low-level outlet valve shaft has been removed. The footings are cracked, and the central pier is in danger of collapse due to the severe cracking at the waterline.

Photo No. 1 - Overall view of spillway from left side. The foot-bridge has been removed. Note the key shaft for the low level outlet valve in the central buttress, and the advanced deterioration of the concrete at the water line.

2. A safe means of lowering the lake should be provided. This would involve restoring the existing outlets to operable condition and reinstating the footbridge across the spillway. This work should commence within six months.

3. Repair all cracked and spalled concrete with epoxy cement within six months.
4. Provide rip-rap protection along entire upstream face within 12 months.

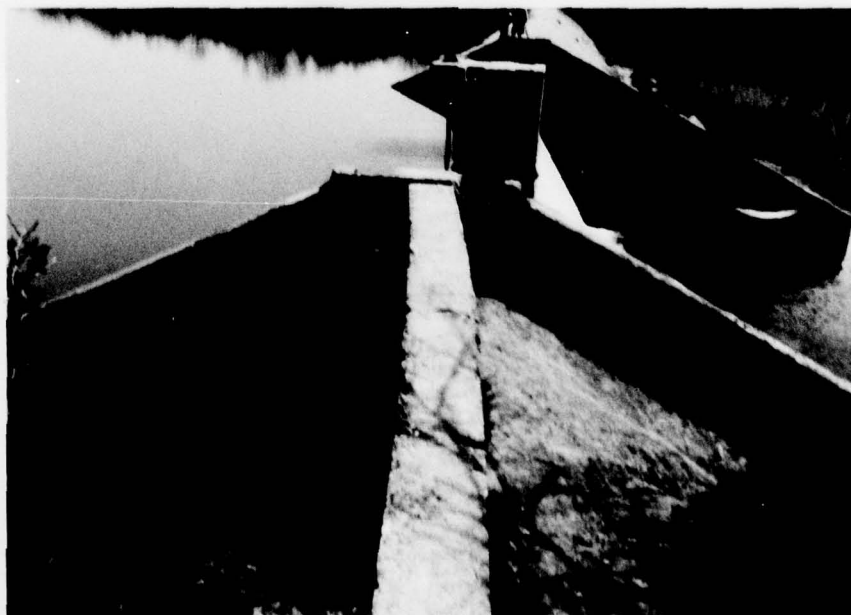
Photo No. 2 - View of spillway from the right embankment showing the exposed core-wall and the left embankment with its concrete cover. Note also the crack in the upstream wingwall and the general deterioration of concrete.

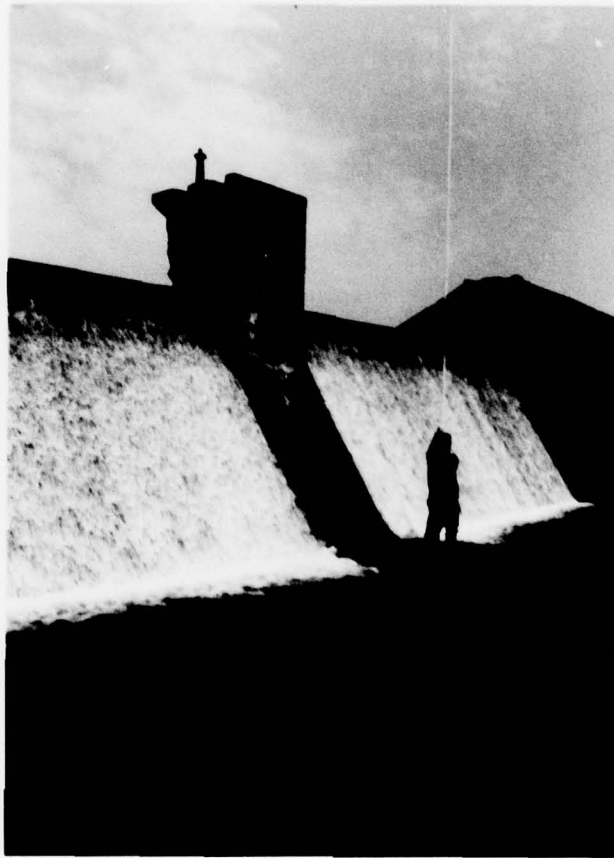
Photo No. 3 - View of spillway from downstream, showing low-level outlet.

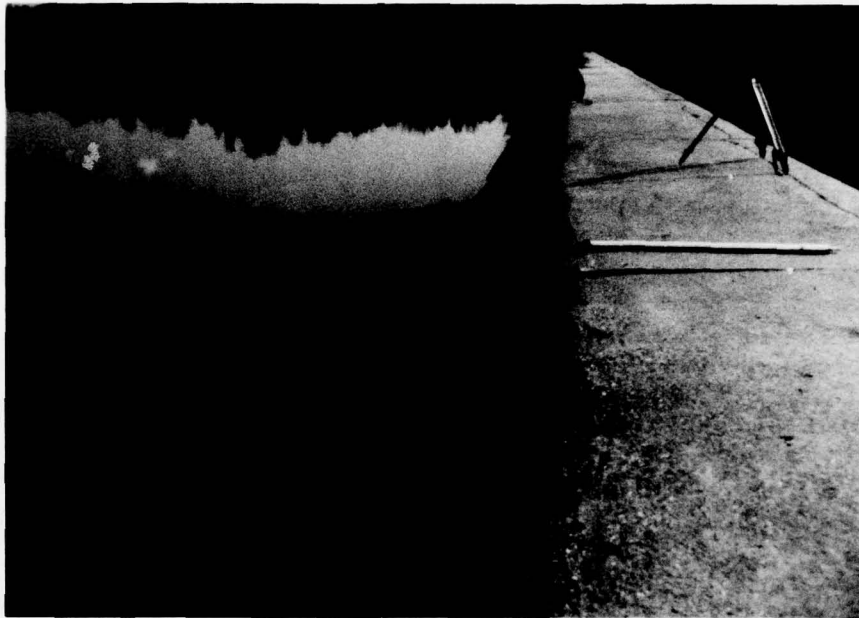
| VISUAL EXAMINATION OF | OBSERVATIONS | REMARKS AND RECOMMENDATIONS |
|---|--|---|
| SURFACE CRACKS | Extensive surface cracking parallel and normal to the axis has taken place on the concrete covering of the left embankment. The most serious cracking is on the upstream side of the crest, where the covering is sheared by up to 6". All cracks appear to have penetrated the full thickness of the concrete. | Additional protection is needed on the upstream face. All other cracks should be repaired with epoxy. No major instability indicated by cracks. |

Photo No. 4 - View of left embankment, covered by concrete to form an emergency spillway. Extensive cracking has occurred and vegetation is growing in the cracks.

5. All brush and trees should be removed from the downstream and upstream slopes to avoid problems which may develop from roots. The embankment face should then be seeded to develop a growth of grass for surface erosion protection. Remove all vegetation from cracks. This program should be started within 12 months.

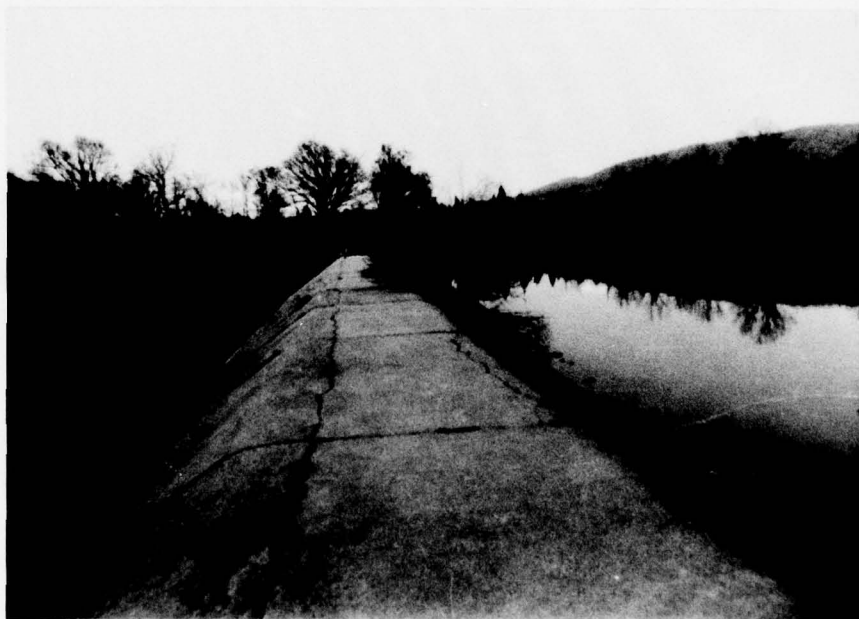
Photo No. 5 - View of left embankment looking towards the spillway. Note that toe protection has been provided along the length of the embankment.

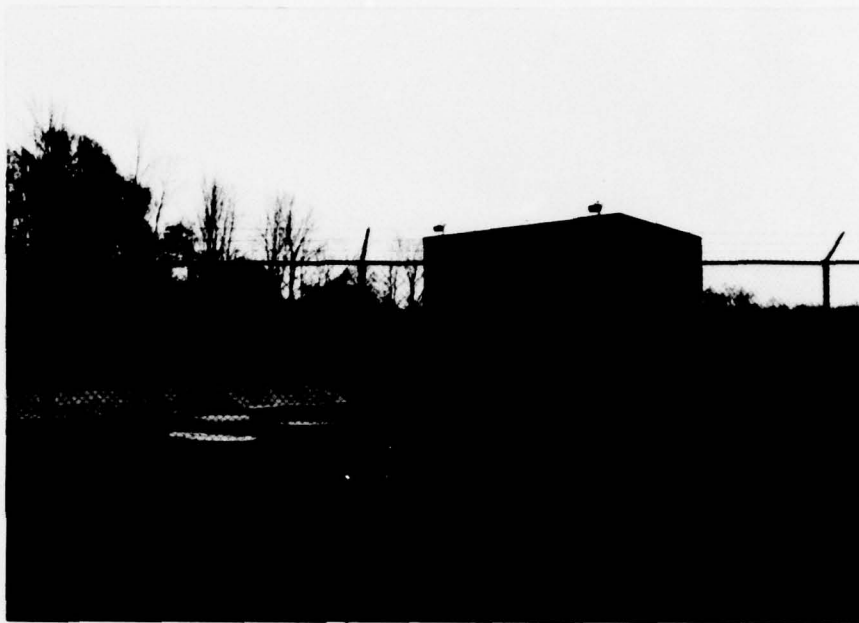
Photo No. 8 - View of valve house 1,000 feet downstream of the dam. The valve house controls an outlet from the Round Valley Reservoir.
